NATIONAL DAM SAFETY PROGRAM. LITTLE CHOCONUT WATERSHED SITE 2E --ETC(U)

JUN 81 H C FLAHERTY

⑥ National Dam Safety Program. Little Choconut
Watershed Site 2E Dam (Inventory Number NY 723)
Susquehanna River Basin, Broome County, New
York. Phase I Inspection Report.

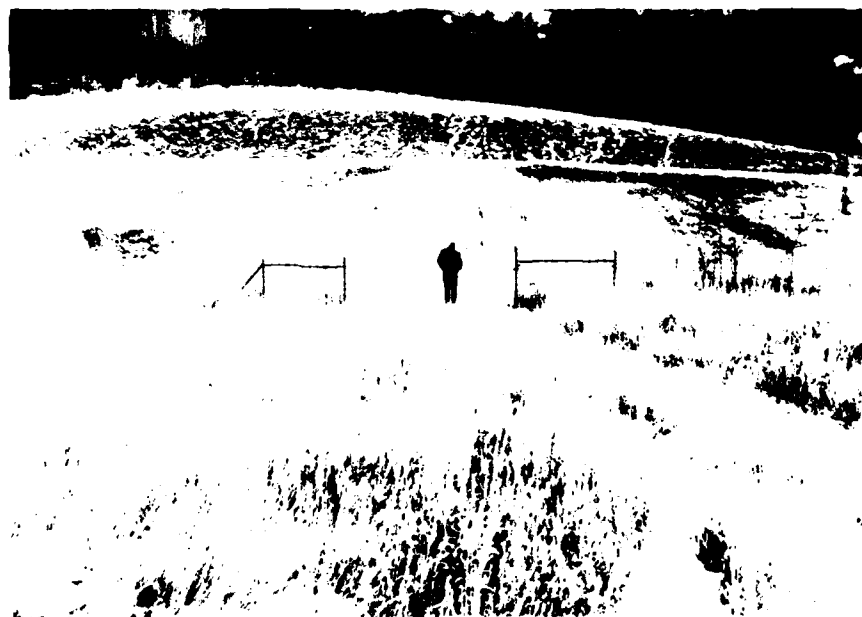
4. The gate was open and apparently traffic has worn slight ruts along the crest (See Photo No. 3).
5. A small quantity of broken rock was evident at the contact between the upstream embankment slope and the left abutment. This may indicate past erosion.

- c. Toe drain pipes discharging on either side of the principal spillway outlet pipe project unsupported for about 5 feet.
- d. The gate was open and apparently traffic has worn slight ruts along the crest.

PHOTO #3: Crest of dam looking toward left abutment

1. Repair the small eroded area on the downstream slope at the right abutment using granular fill and broken stone to permit drainage.
2. Mow the grassed slopes of the embankment and emergency spillway channel at least annually.
3. Restore the riprap support or shorten the toe drain outlet pipes.
4. Control access and vehicular traffic and take necessary measures to prevent further rutting of the crest.

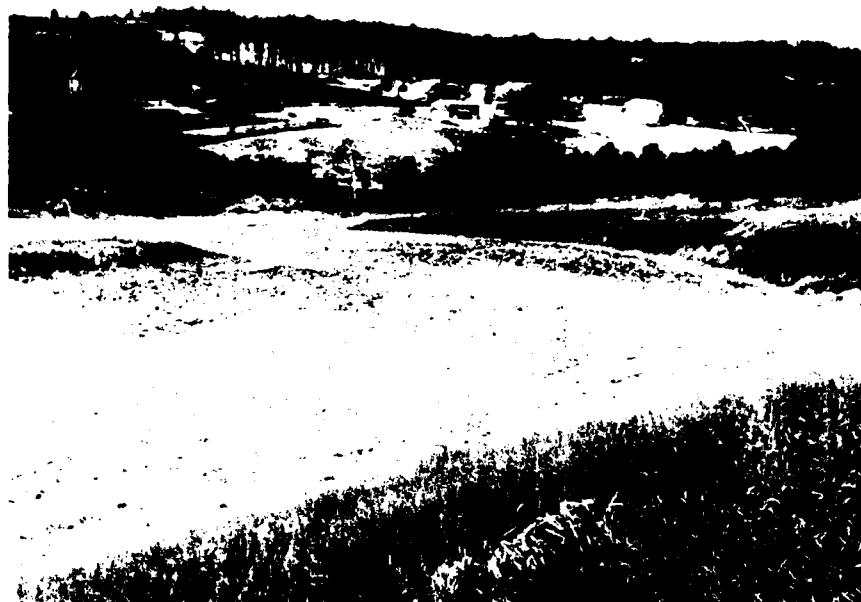
The emergency spillway is 120 feet wide and is located on the left abutment. It has a vegetated surface consisting of 6 inch high grass. The approach channel, level crest, and exit channel are generally in good condition (See Photos No. 6, 7 and 8). The grass cover on the spillway and along the crest of the earth dike separating the spillway from the embankment has been disturbed in several areas by footpaths and motor vehicles. The crest of the spillway and bottom of the exit channel appear to

PHOTO #6: Emergency spillway looking upstream

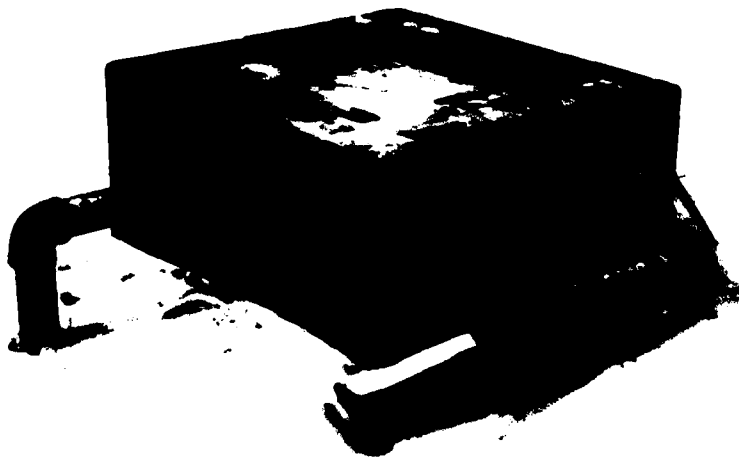
The reinforced concrete drop inlet structure is in excellent condition. However, there was a moderate amount of debris on and in front of the metal trash rack (See Photo No. 9). The gate stem for the low level drain was observed but not operated during the inspection.

- f. A small quantity of broken rock was evident at the contact between the upstream embankment slope and the left abutment.
- g. Debris was observed on the trash rack at the orifice of the principal spillway concrete riser.

PHOTO #9: Drop inlet structure

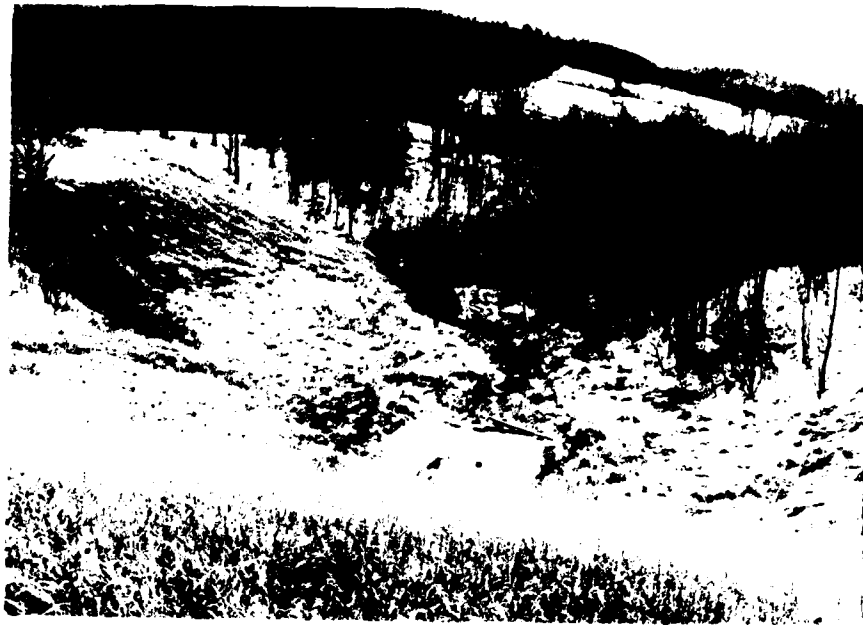
The downstream channel is in good condition, with no signs of degradation or aggradation (See Photo No. 12).

PHOTO #12: Downstream channel conditions
